**SAS Superstructure**

Daily Diary Report by Bid Item

Contract No.: 04-0120F4

04-0120F4
04-SF-80-13.2/13.9
Self-Anchored
Suspension Bridge

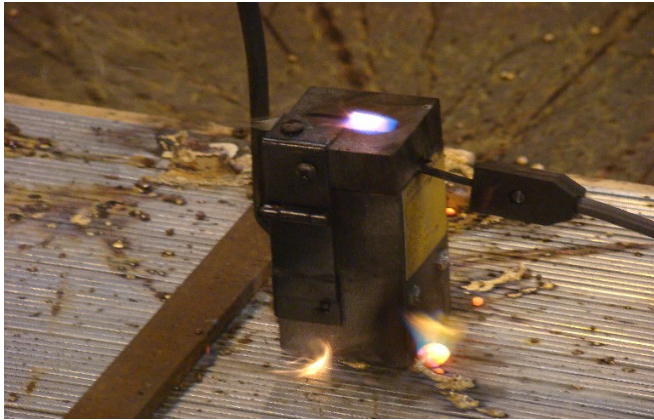
The Cadweld fuse box in the process of being ignited.

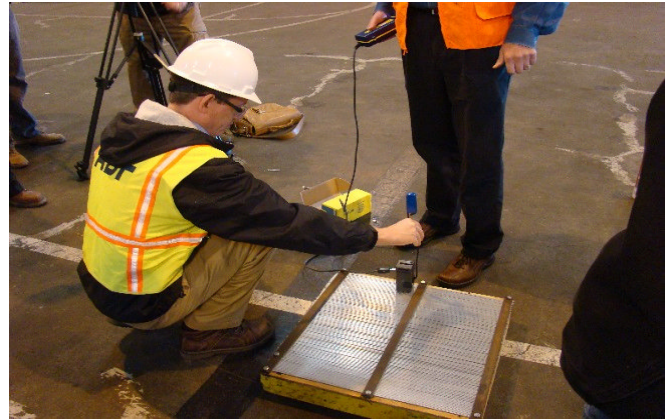
Cadweld demonstration where the fuse box had to be ignited to deposit the molten weld to the main cable wrapping wire splice.

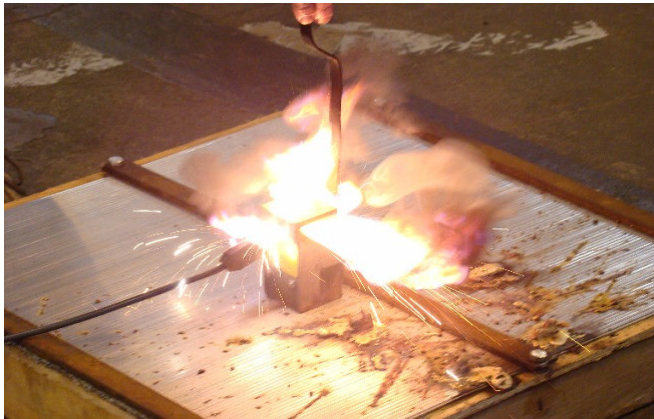
The grain packet in the Cadweld fuse box ignited creating the molten/liquid weld material.

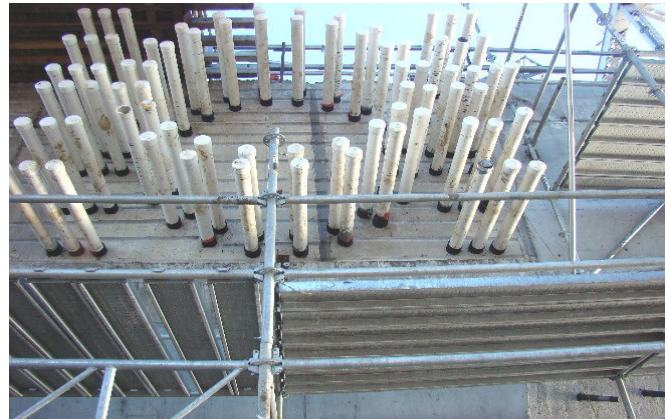
- Investigated/inspected the W2E Hinge K concrete surface for acceptance. The issue of cleaning and not roughening the concrete surface was discussed early in the day with ABF superintendent Scott Smith. The concrete surface particularly in question was the W2E South Hinge K where there was a grout streak and laitent debris (aged polystyrene that was a yellow color) on the surface that needed to be cleaned prior to the Hinge K pipe beam assembly being erected. It should be noted that myself and Ken Beede jointly decided on the conditions of acceptance for the concrete surface prior to erection of the Hinge K pipe beam assemblies.

A grinder was used to remove the grout streak and it smoothed the concrete surface too much. Additionally the ABF laborers used the grinder to clean the concrete surface in a few areas at the bottom of the concrete face and were stopped. Since the grout streak couldn't be removed with a wire brush the grinder was the only option. However the grinder was not acceptable for the remaining areas to be cleaned because it made the surface too smooth. A surface roughness of 3 (seen in the photo below) as prescribed by the International Concrete Repair Institute was to be retained while cleaning the concrete which was already in place. A video was taken to demonstrate this condition of acceptance to clean the concrete while maintaining the in-situ surface roughness with the wire brush. It was recommended to ABF supervisors to use a pressure washer to clean the surface. This option is the preferable method suggested by ASTM. Also ABF used this technique for the W2/OBG closure joints. They did not exercise that option citing concerns of safety and rewapping the Macalloy rods.

The condition of the W2E South Hinge K concrete surface at the beginning of the day which was NOT acceptable due to a grout streak and laitence debris

ABF engineer Zach Lauria was very resistant/defiant to clean the concrete surface prior to the erection of the W2E Hinge K pipe beam assemblies. I referred to the project Special Provisions section 10-1.56, Standard Specifications Section 51-1.13, RFI 1240R00, ASTM specifications for concrete surface prep. numbers D4258, D4259, and the Bridge Construction Memo 105-7.0. It was emphasized that even though the shear resistance was more than achieved with the shear keys approved in RFI 1240R00 the surface needed to be cleaned. The intent is to achieve a proper bond between the concrete and grout to mitigate cracking for even the slightest amount of movement especially at this area where seismic loads will be transferred.

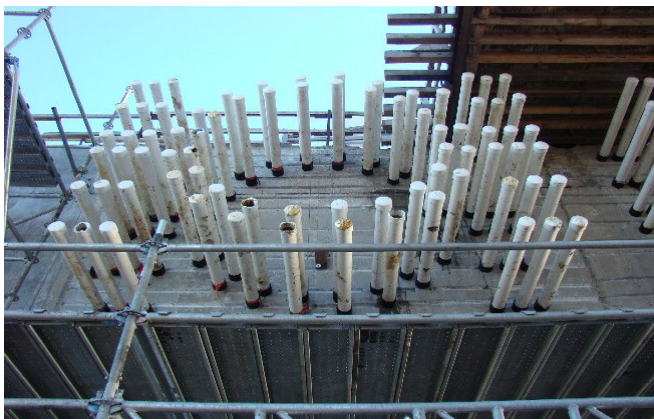
The condition of the W2E North Hinge K concrete surface at the beginning of the day which was nearly acceptable.

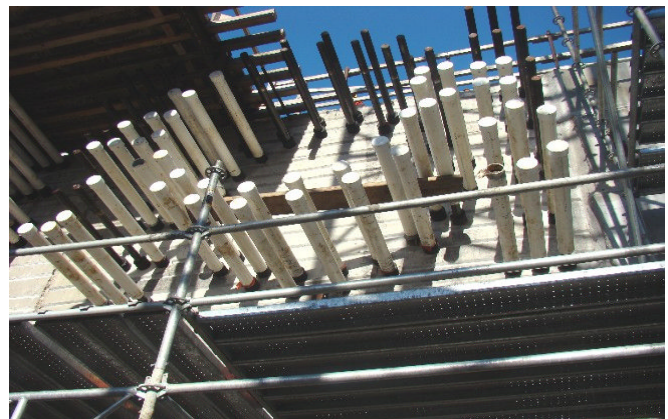
Concrete surface at the end of the day for the W2E South Hinge K concrete surface for the grout pad.

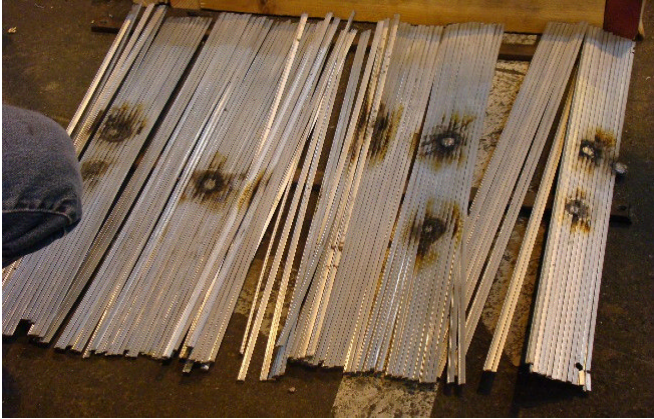
Samples of the splice welds to be tensile tested at Translab in Sacramento.

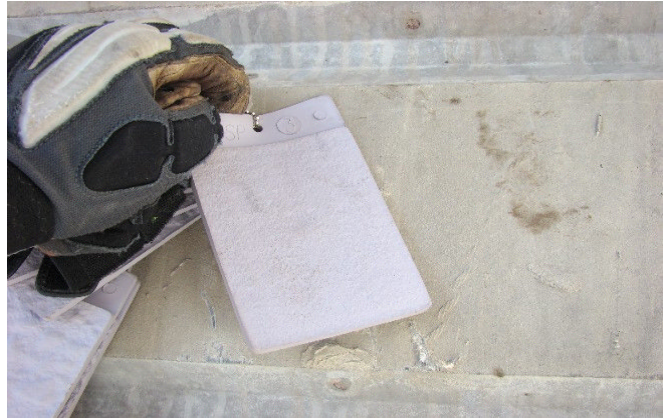
Concrete surface roughness of 3 to be intact after cleaning to ensure a proper bond between the grout and W2 concrete.
